20-251E

September 12, 2003

Re: **World Trade Center**
New York, New York

One World Trade Center

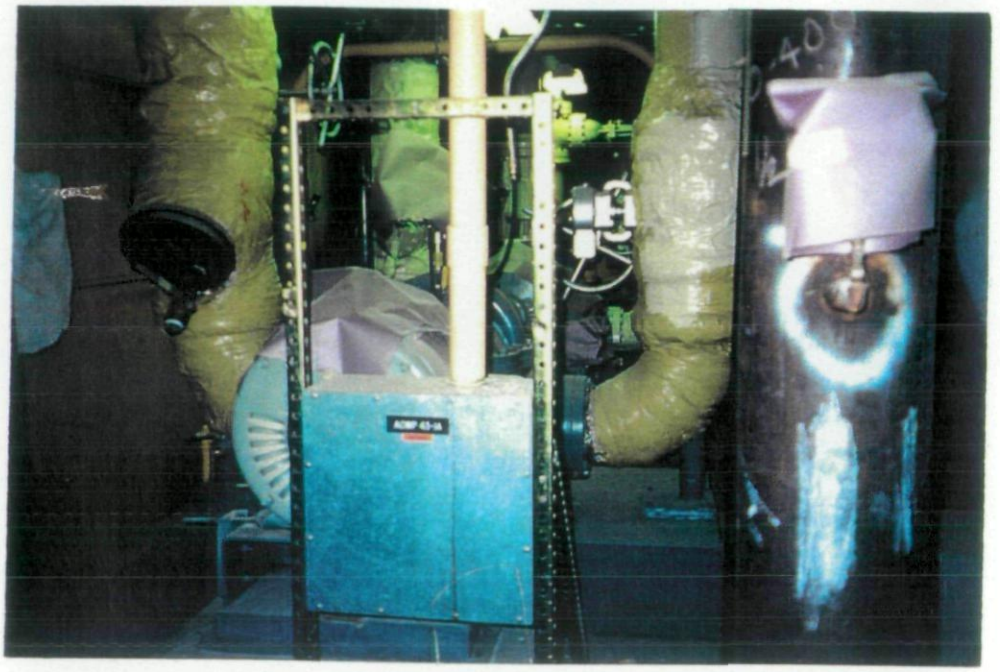
Photograph M1

Condenser water system #2 pump

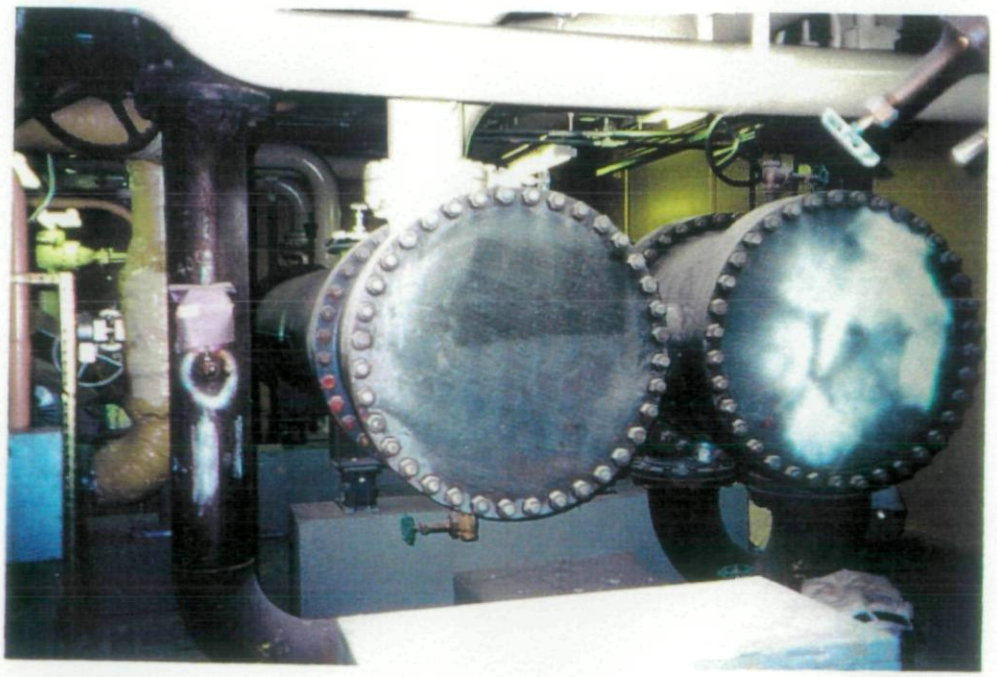
Photograph 2

Condenser water system #2 heat exchangers

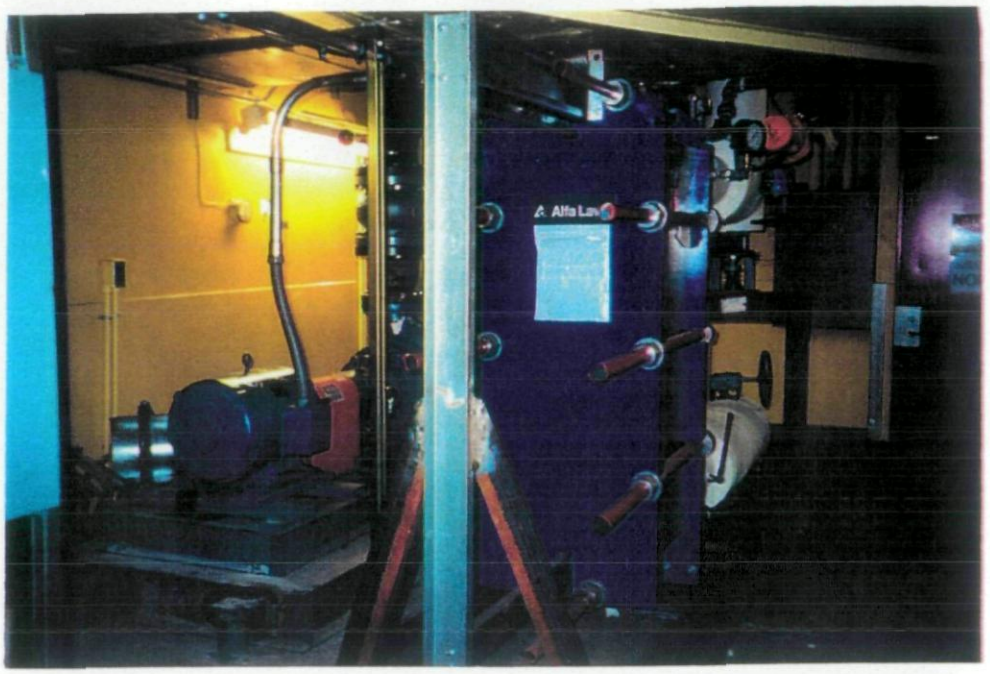
Photograph M3

New condenser water system #2 pump and plate and frame heat exchanger

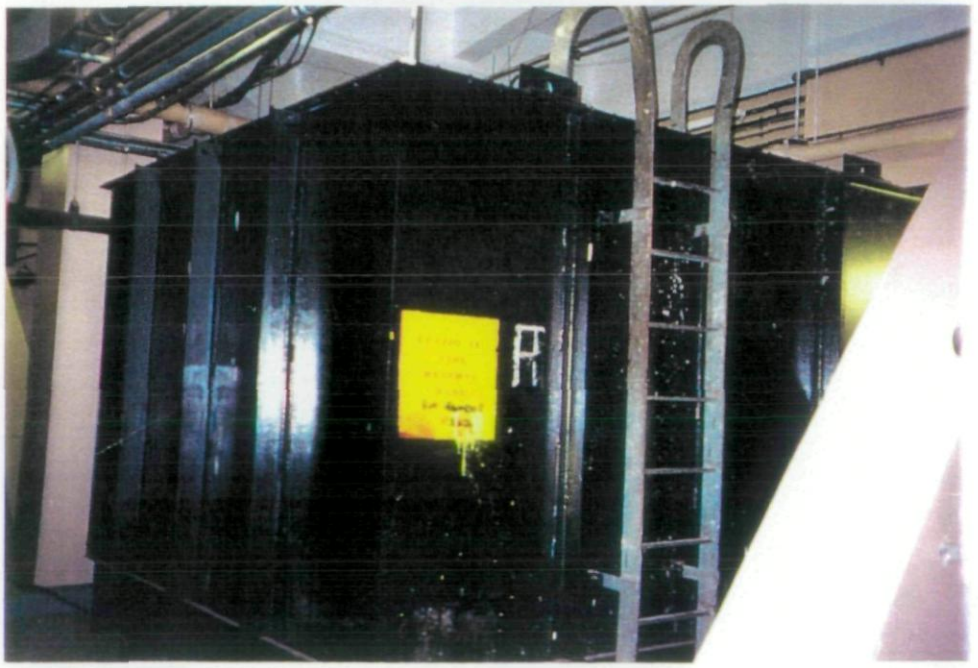
Photograph M6

5,000 gal. standpipe fire reserve tank

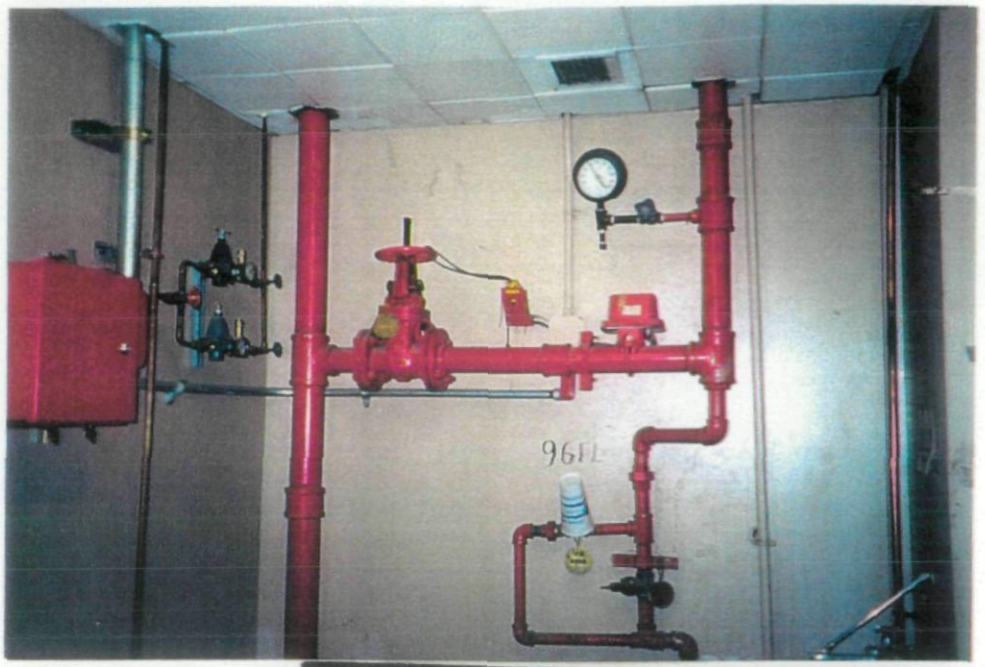
Photograph M7

Typical floor sprinkler control valve room with sprinkler supply line and flow and tamper switches

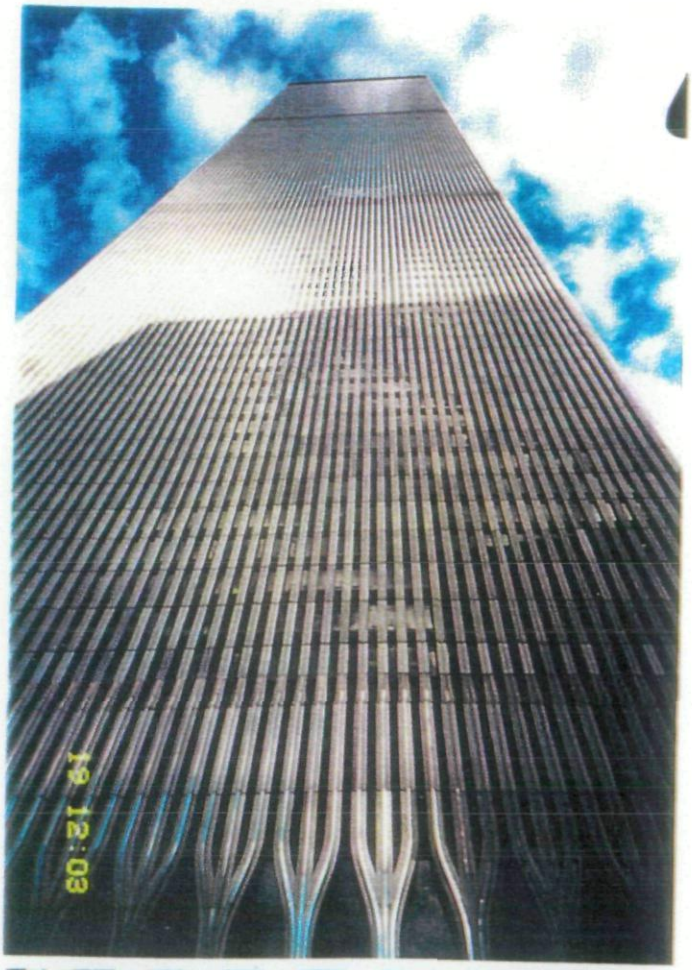
Photograph 1

Liberty Street elevation

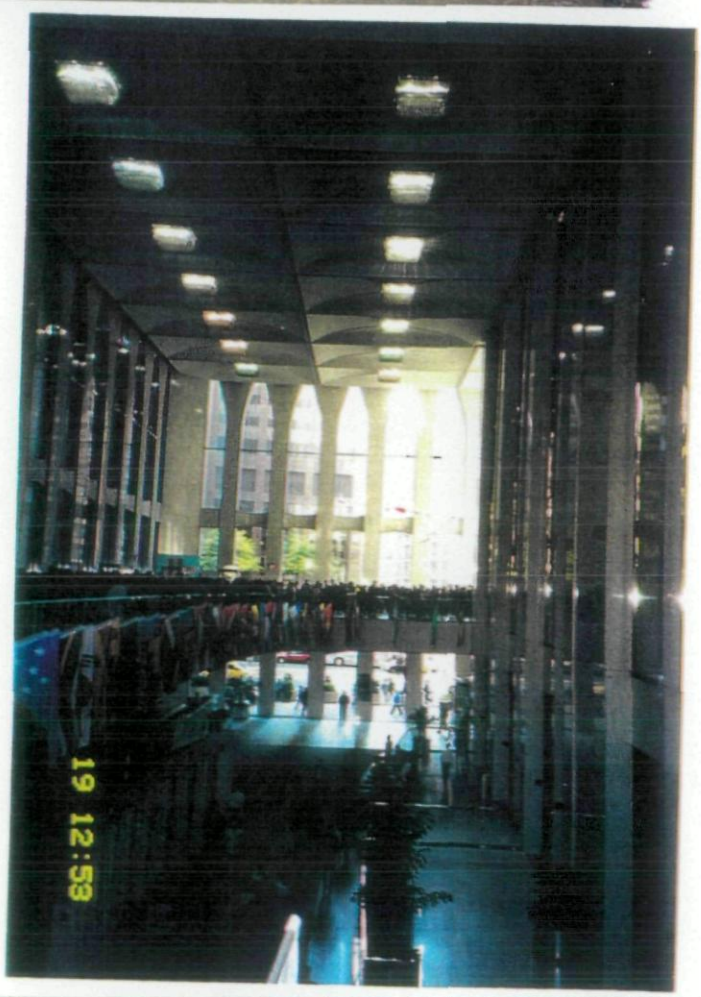
Photograph 10

Lobby and mezzanine

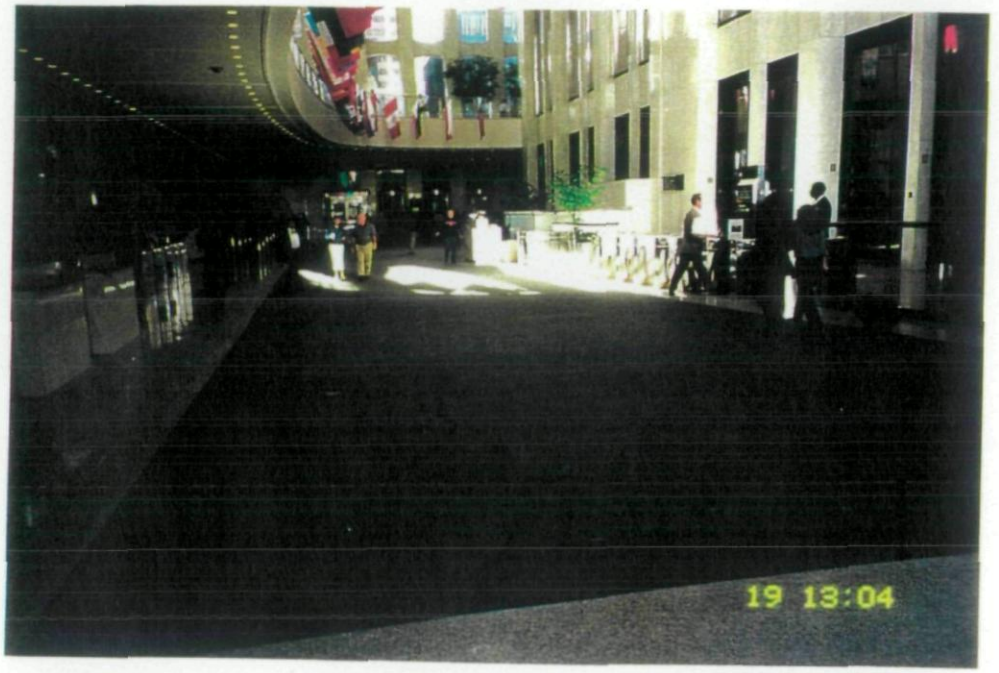
Photograph 11

Lobby - visitors desk on left, security gates to elevators on right

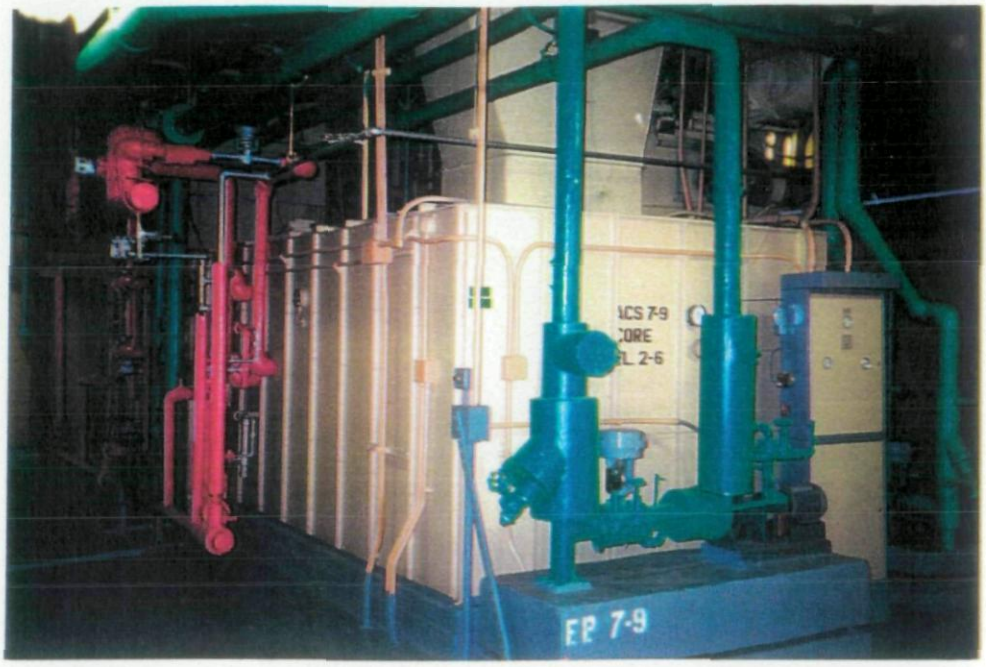
Photograph M1

Typical 7th floor mechanical room air handler and abandoned freeze protection pump system

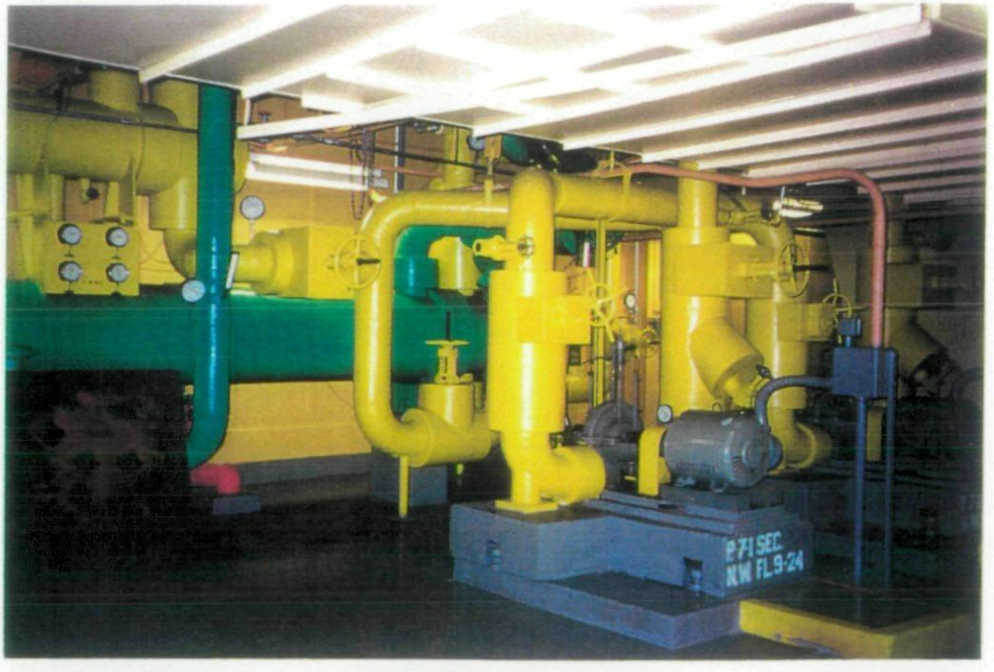
Photograph M4

Steam and chilled water heat exchangers and secondary heating/chilled water pumps

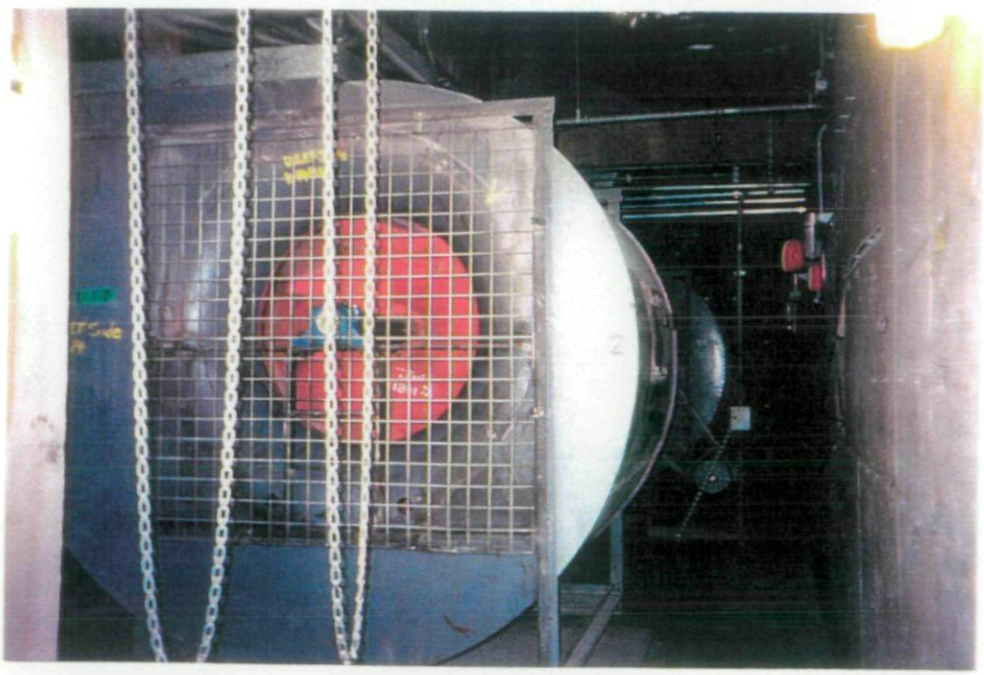
Photograph M6

7th floor mechanical room air handler return air fan

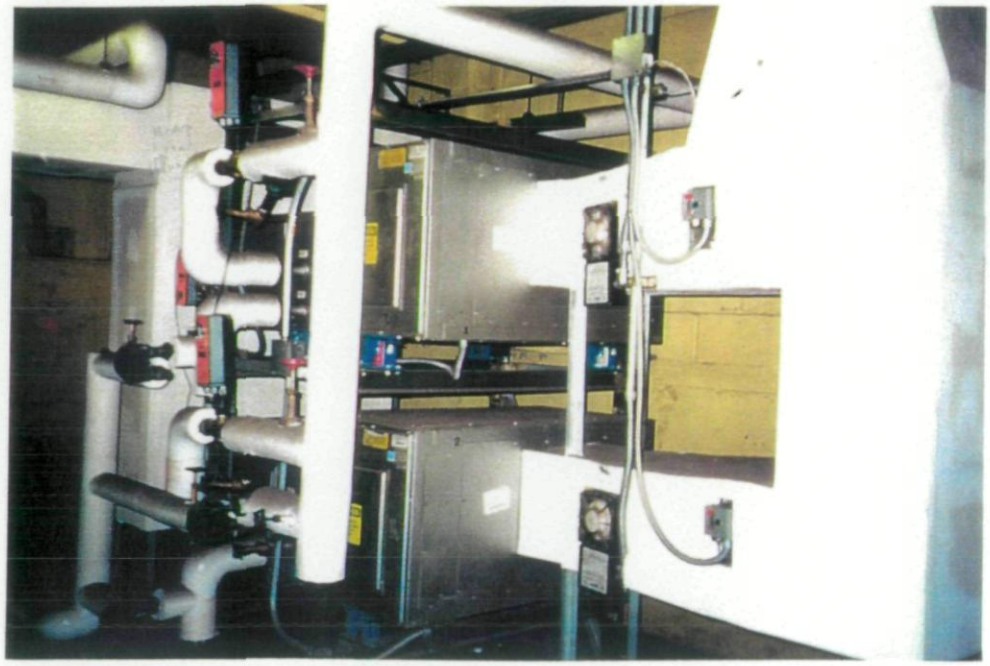
Photograph M7

New H&V units, with steam coils, located in the B-6 Level mechanical room

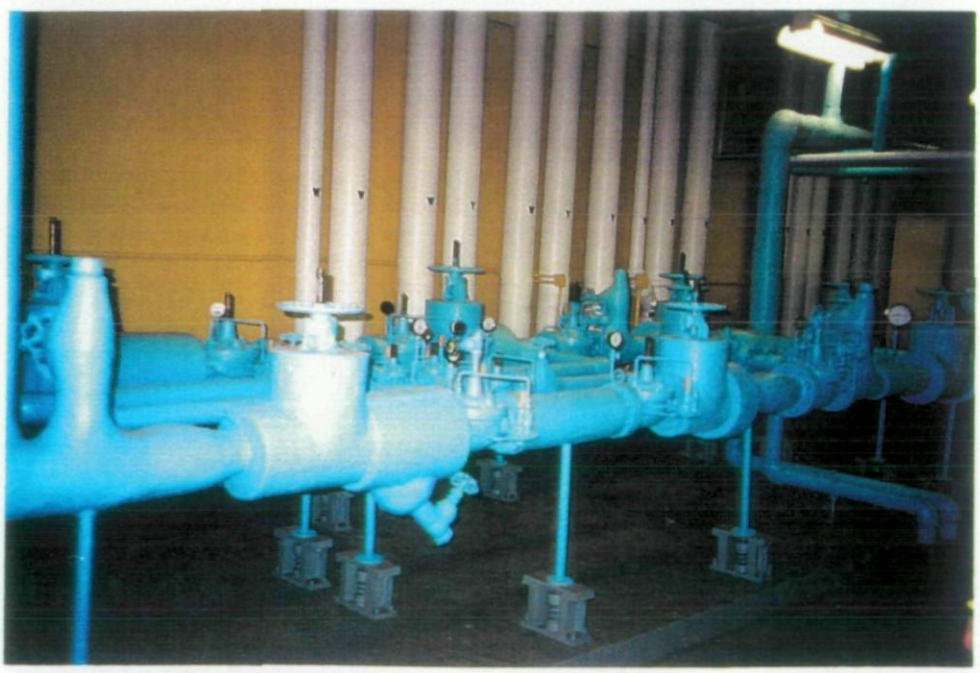
Photograph M8

Domestic water pressure reducing station

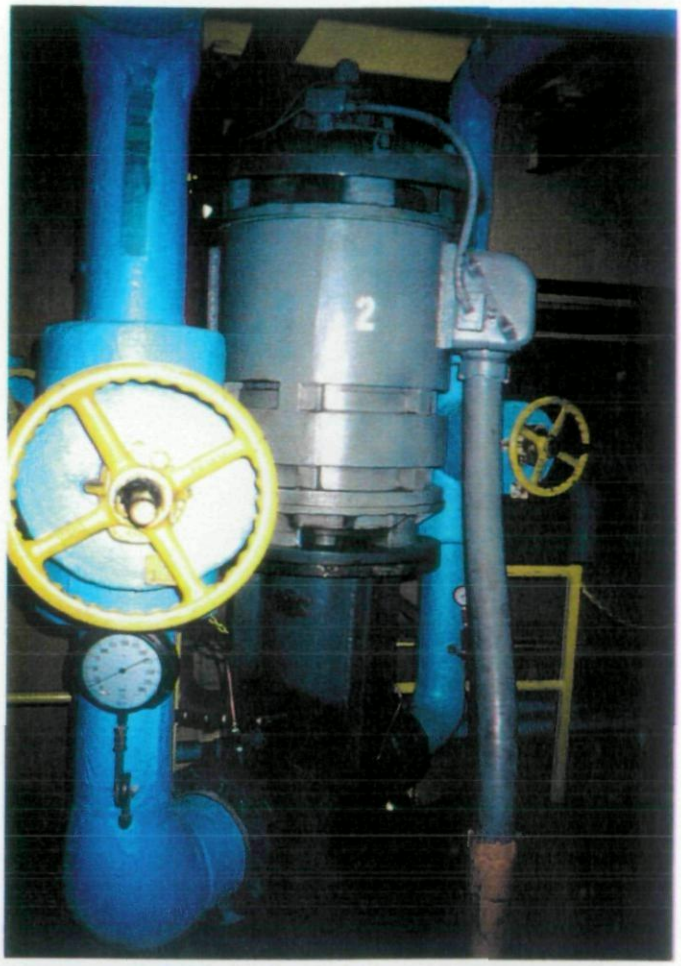
Photograph M9

Domestic water booster pump

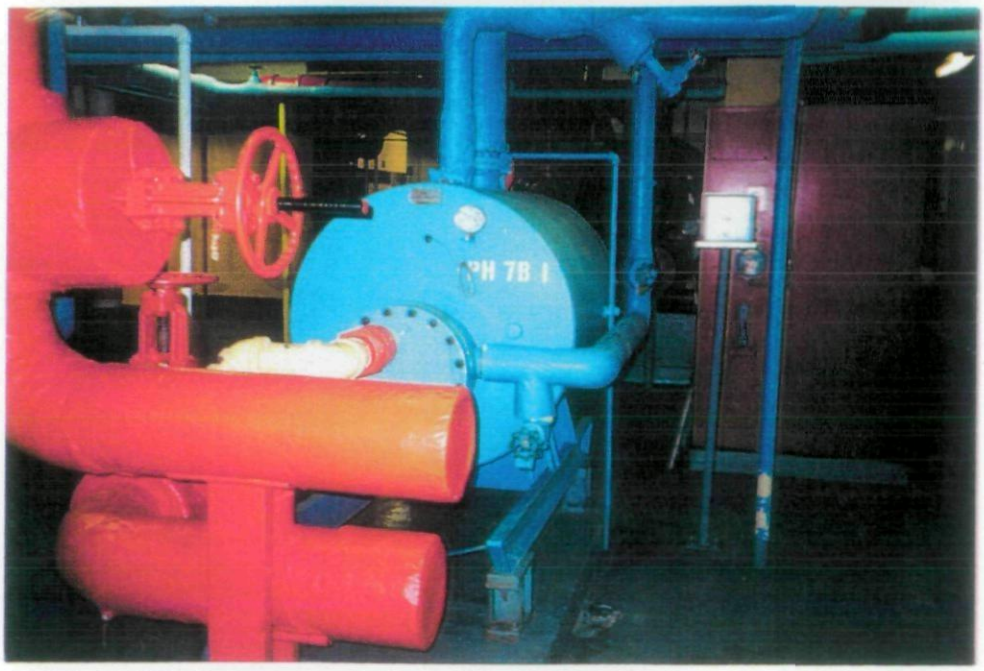
Photograph M10

Domestic water preheat tank

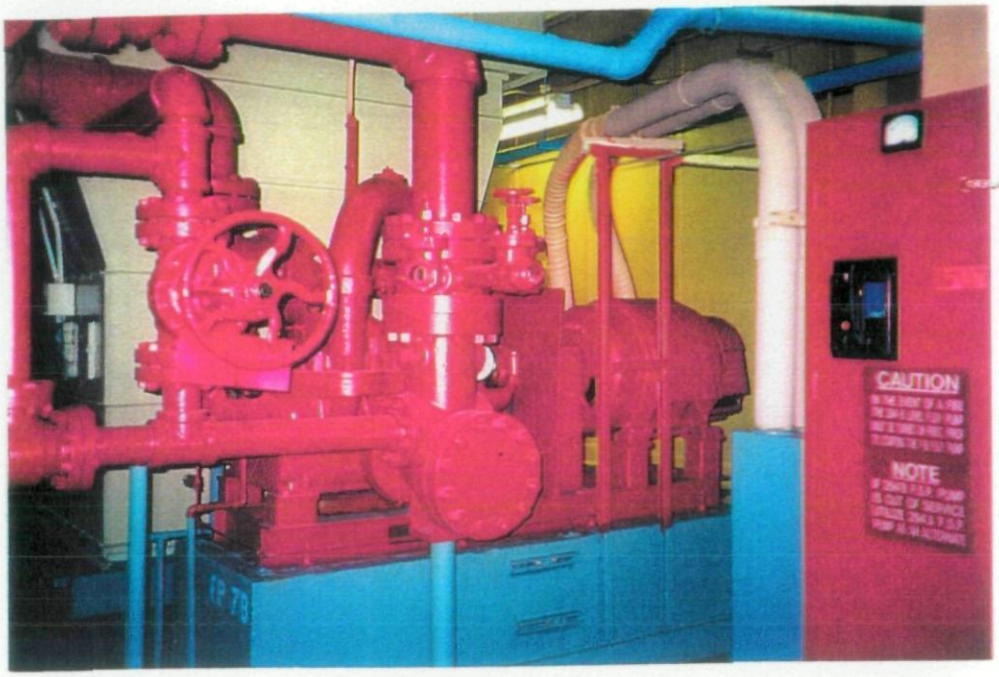
Photograph M13

Electric fire pump located in the 7th floor mechanical room

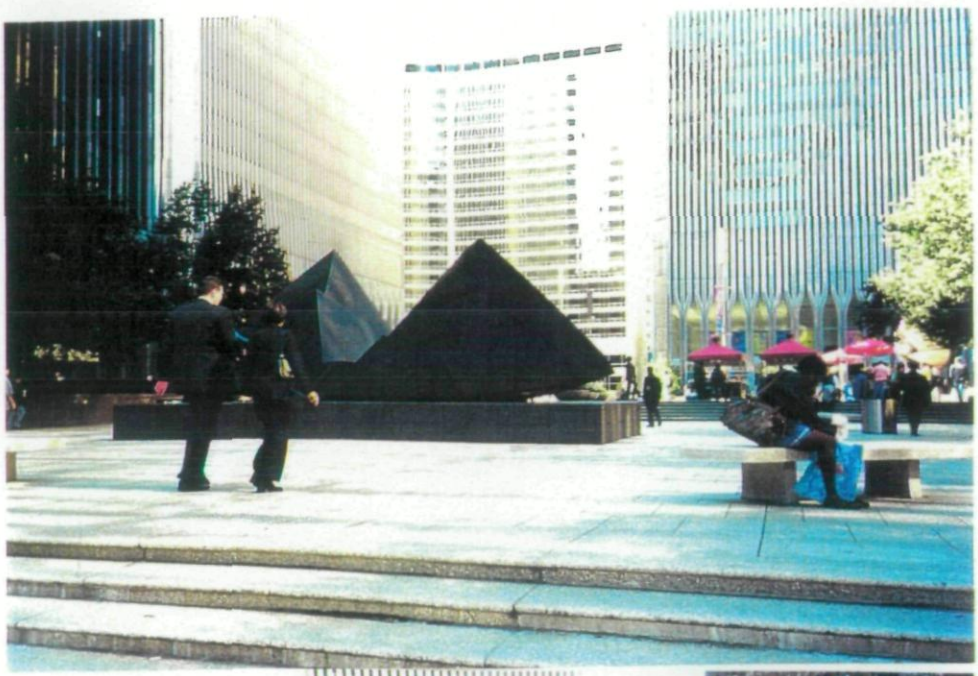
Photograph 15

Damaged Plaza pavement under overhang for 4 WTC

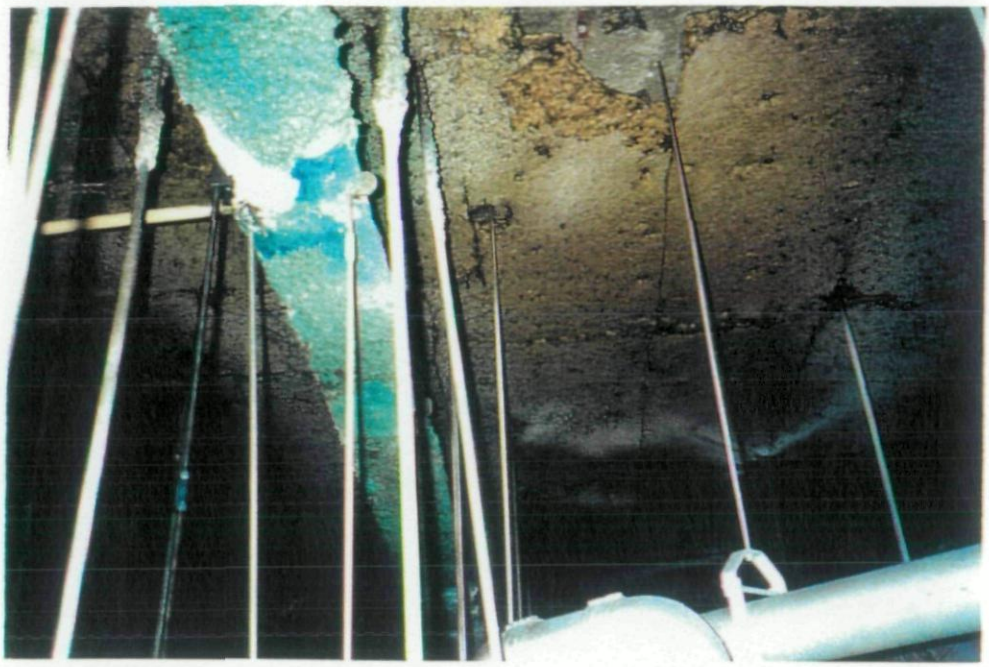
Photograph 18

Leaks at underside of Plaza deck visible near 1 WTC entrance

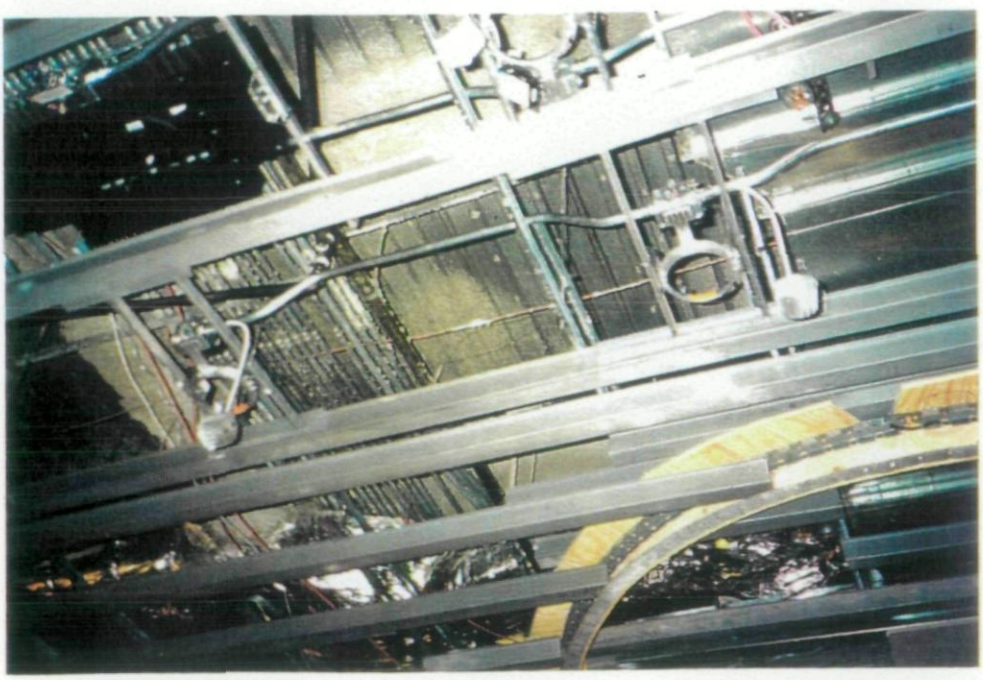
Photograph 20

Metal deck and framing for Plaza level visible from construction area in Concourse level

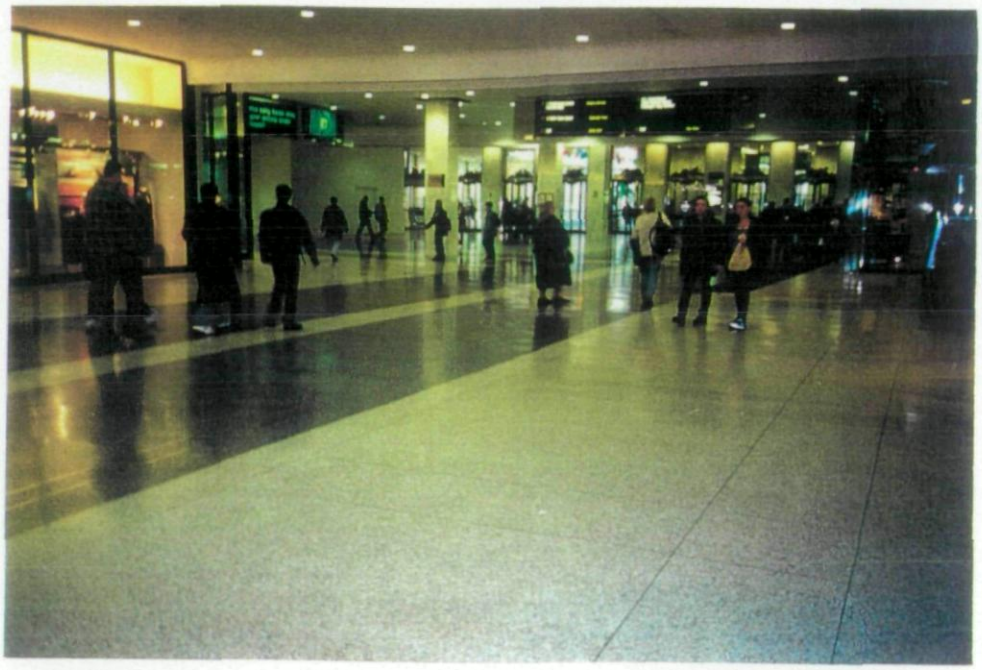
Photograph 31

New terrazzo flooring in the north Concourse corridor looking west towards 1 WTC

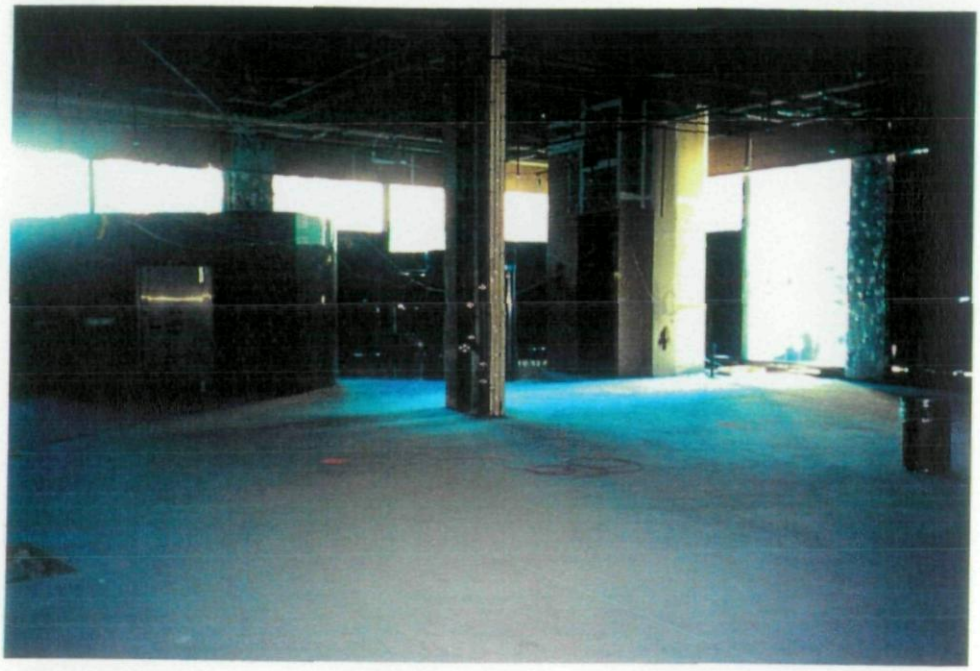
Photograph 47

Vacant retail space at Plaza level below 4 WTC

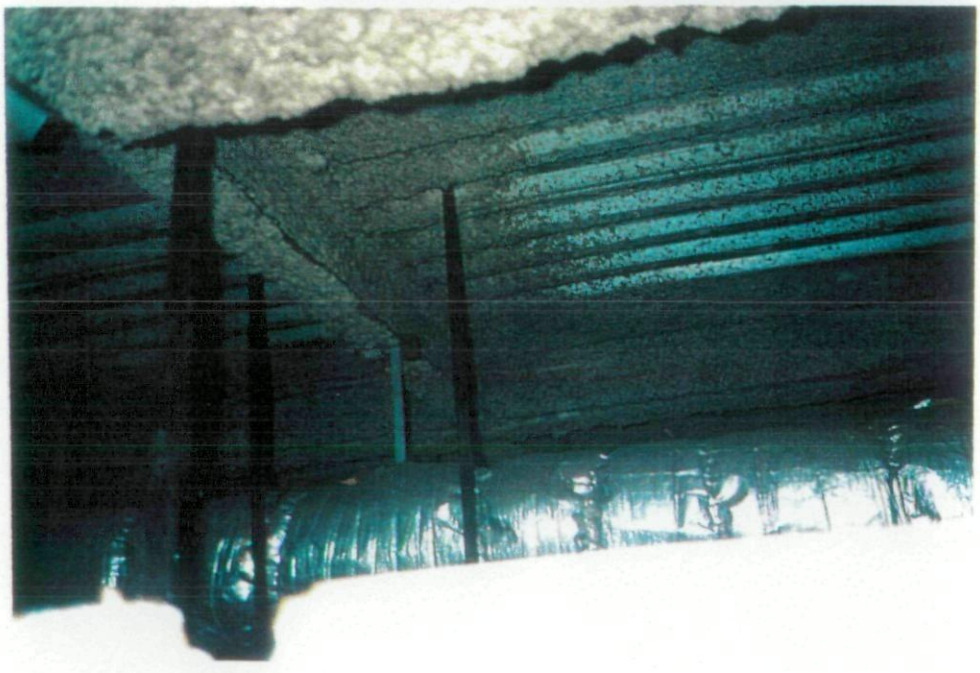
Photograph 6

Framing of cantilever below 4th floor deck

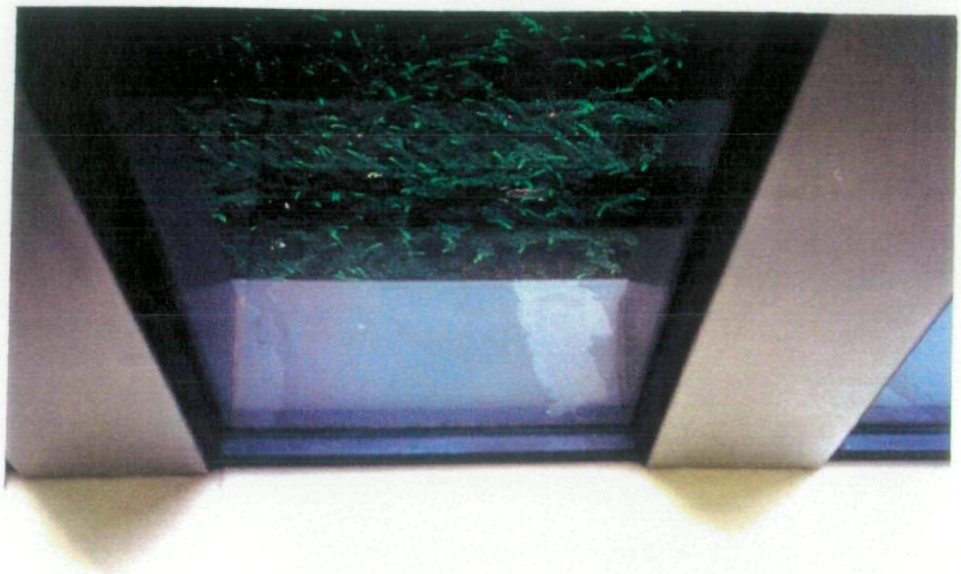
Photograph 13

Detail of sill condition at 4th floor where painted finish is failing

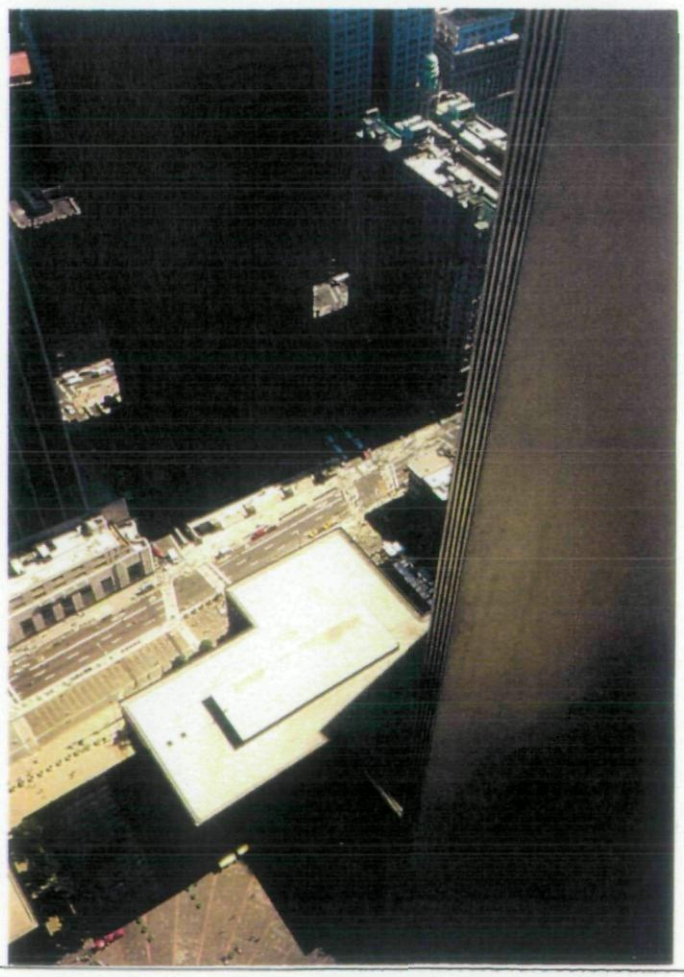
Photograph 14

Roof layout overview from tower

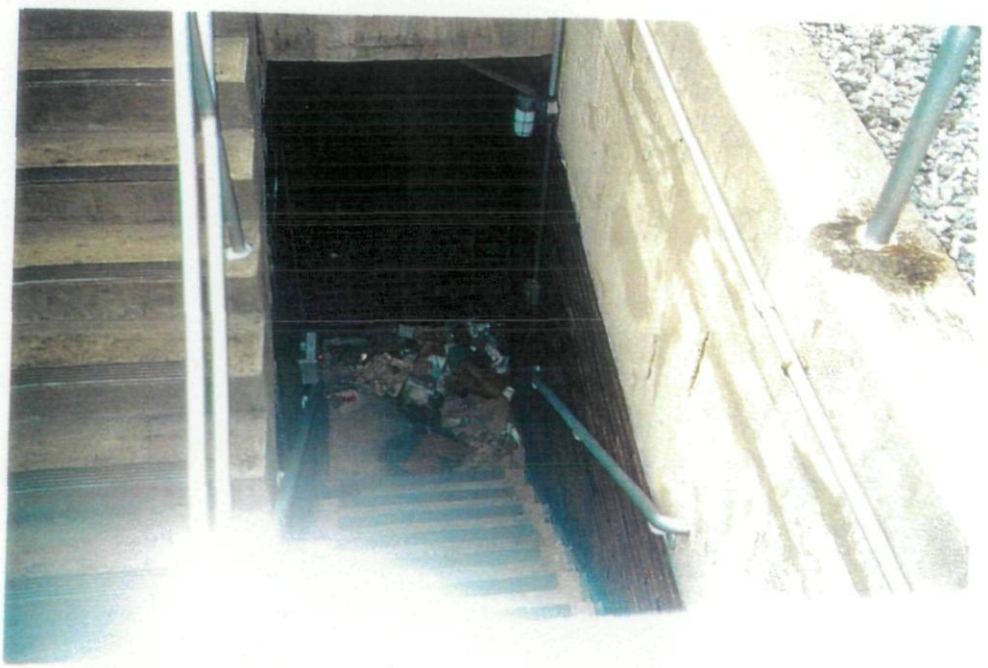
Photograph 16

Southeast stairway exiting into well at roof partially blocked by debris

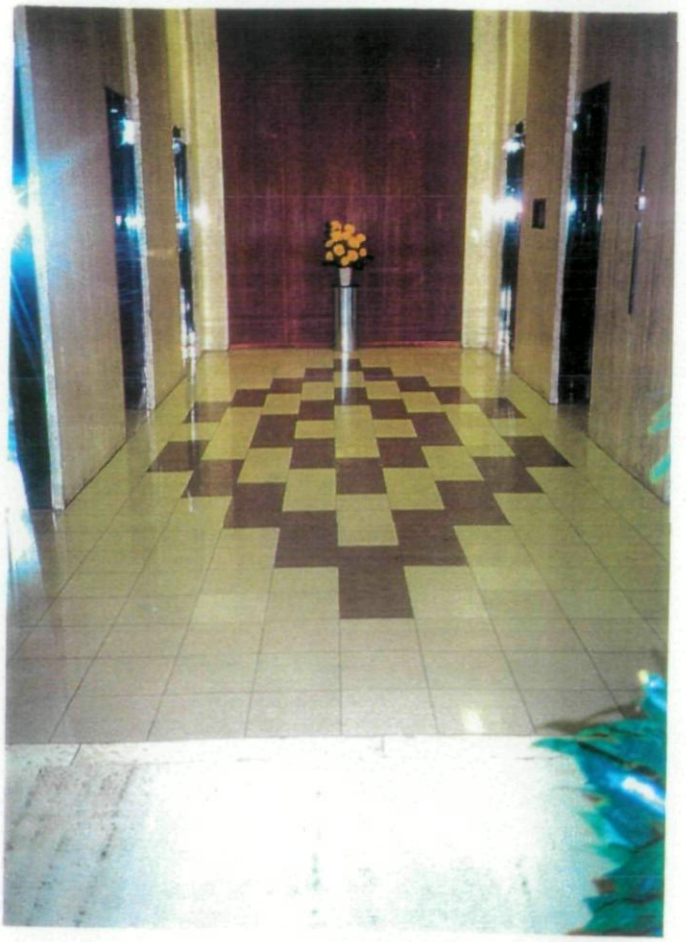
Photograph 19

Plaza level elevator lobby

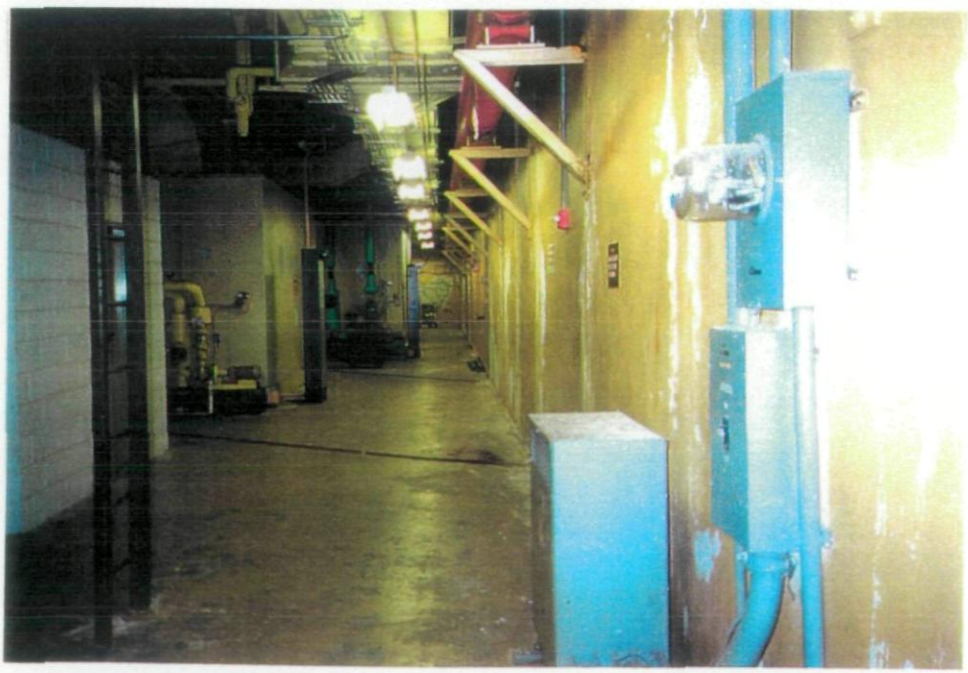
Photograph 28

Mechanical equipment room finishes on 9th floor

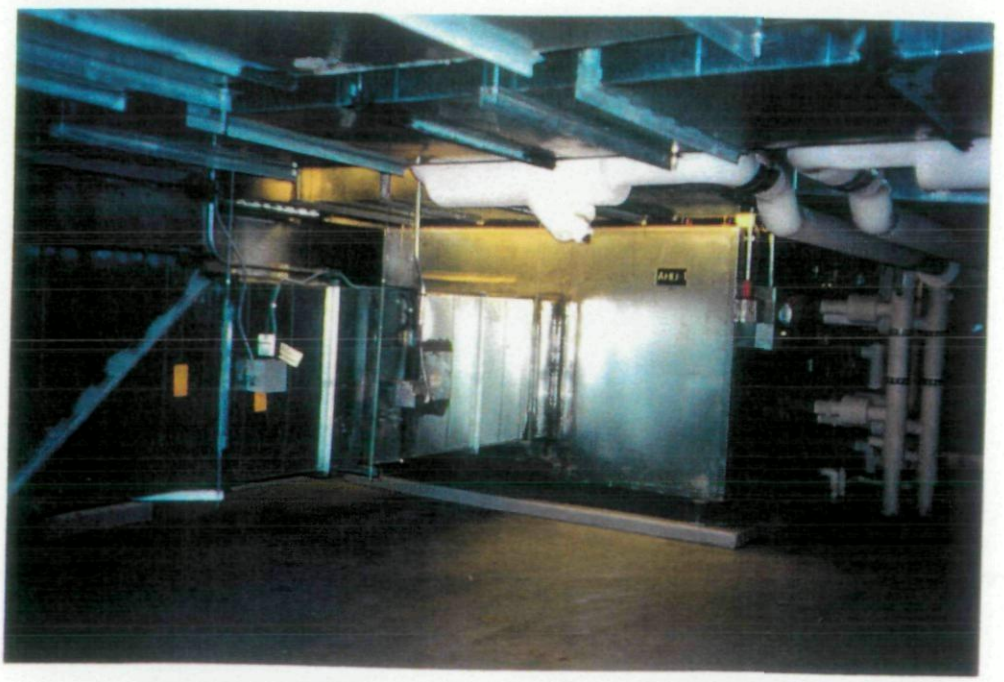
Photograph M2

Air handling unit located in the 3rd floor mechanical room

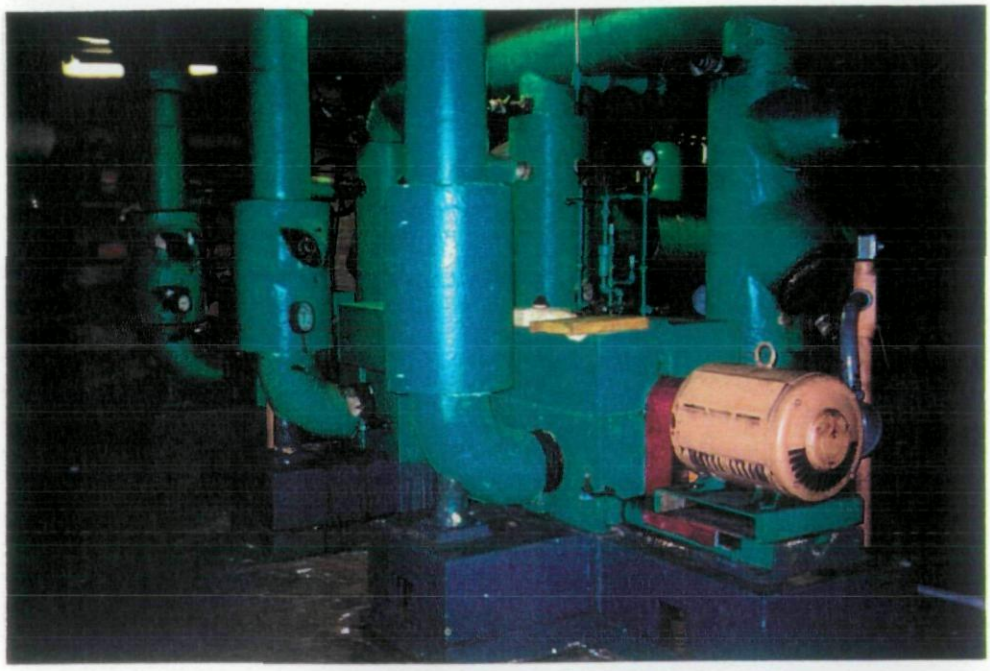
Photograph M3

Chilled water pumps located in the B1 mechanical room

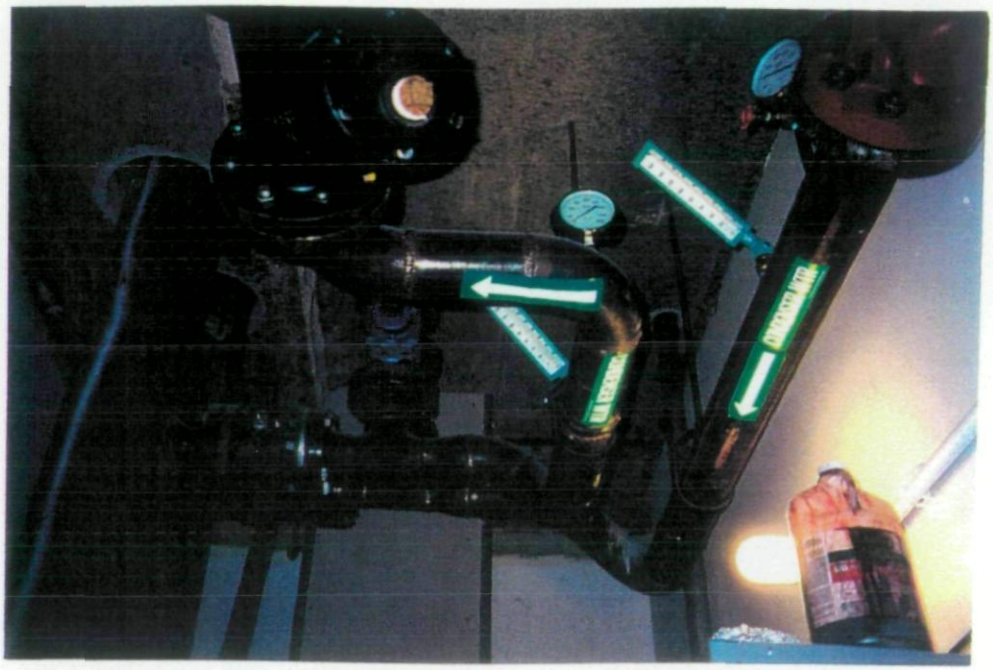
Photograph M5

Condenser water supply and return lines for tenant supplementary air conditioning

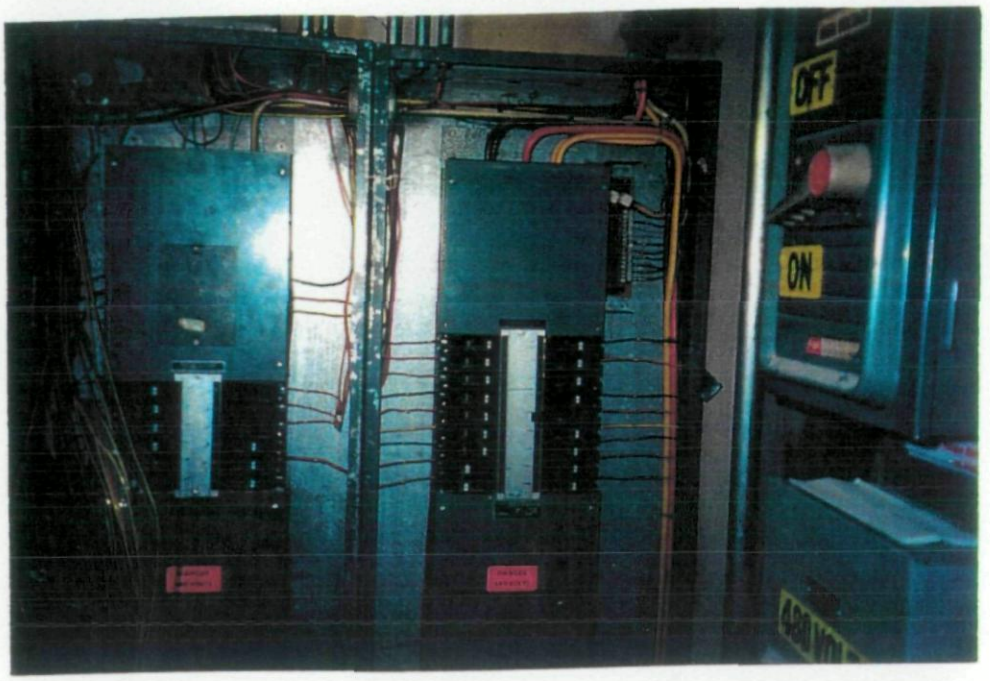
Photograph M9

Electric circuit breaker panels in a typical electric closet

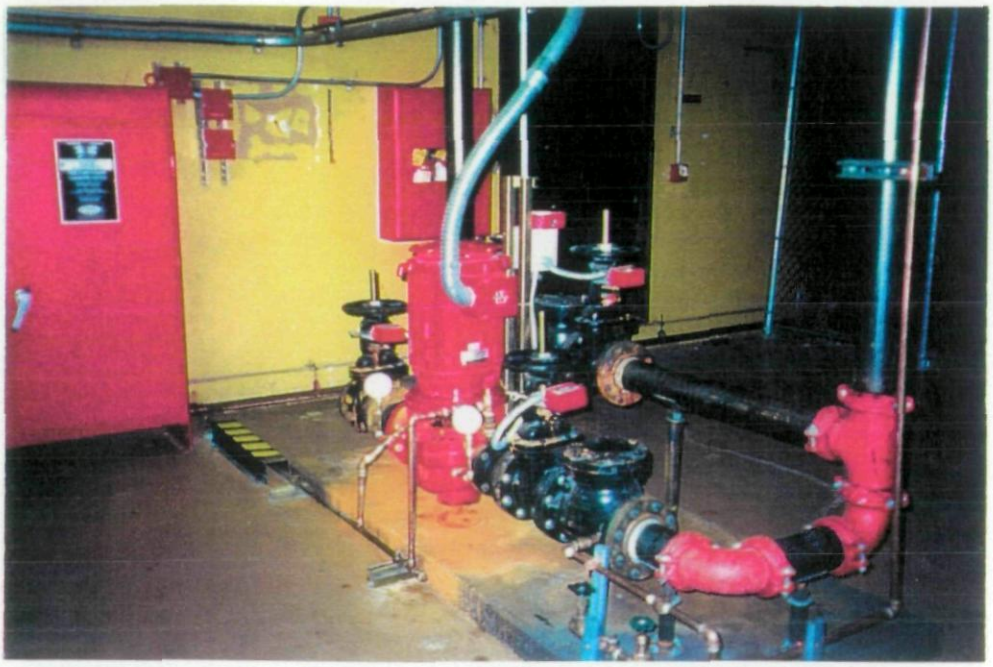
Photograph M11

Booster fire pump located in the 9th floor mechanical room

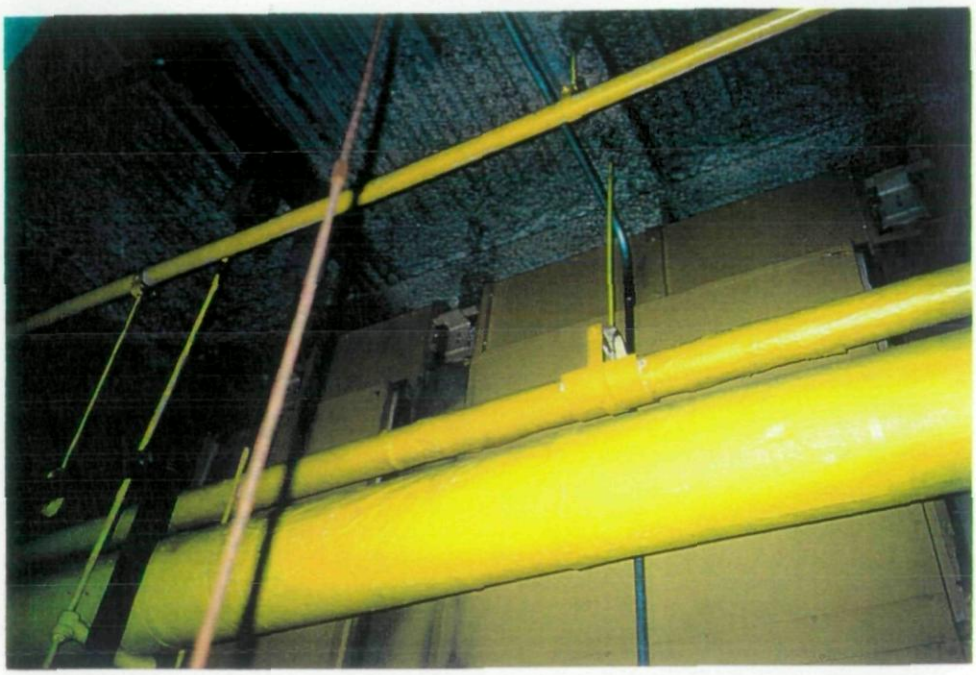
Photograph 3

Roof deck structure with lally-column supports of exterior wall visible at 9th Floor MER

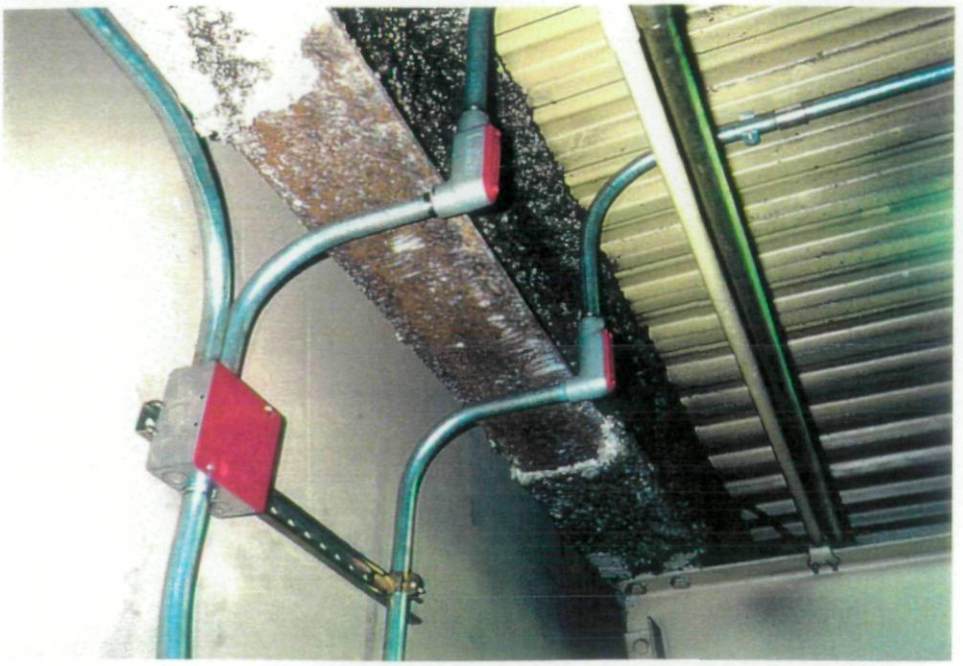
Photograph 5

Example of spray applied fireproofing removed at framing for attachment of equipment
